Contrasting decay of historical building stone: Relationships between petro-physical feature and frontal polymerization treatment suitability on medieval building of north Sardinia (Italy).

Contrasting decay of historical building stone: Relationships between petro-physical feature and frontal polymerization treatment suitability on medieval building of north Sardinia (Italy) / Cuccuru, Stefano; Oggiano, Giacomo; Meloni, Paola; Mariani, Alberto; Mameli, Paola. - In: BULLETIN OF ENGINEERING GEOLOGY AND THE ENVIRONMENT. - ISSN 1435-9529. - 78:3(2019), pp. 1669-1682. [10.1007/s10064-018-1242-5]

Bulletin of Engineering Geology and the Environment

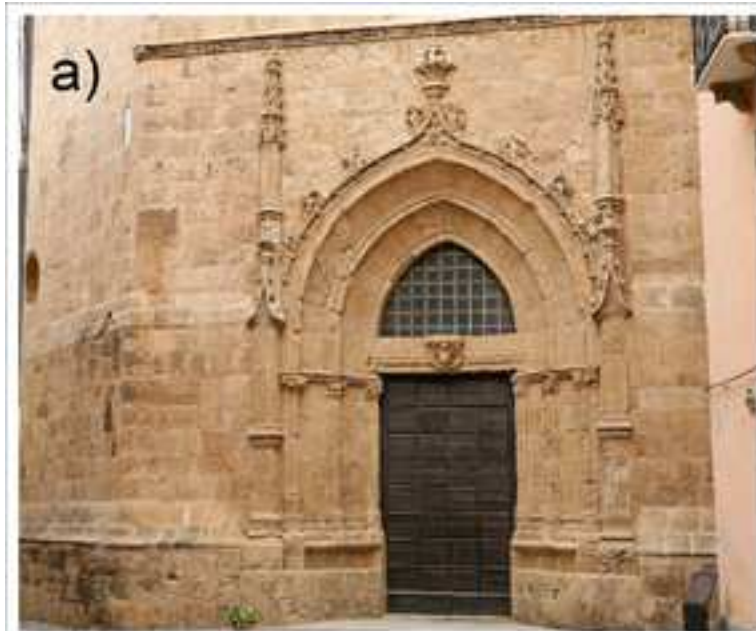
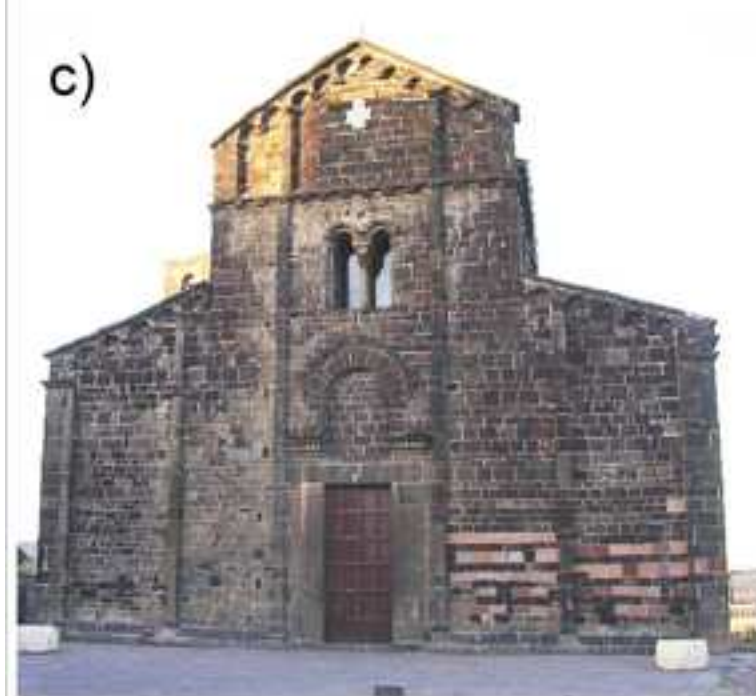
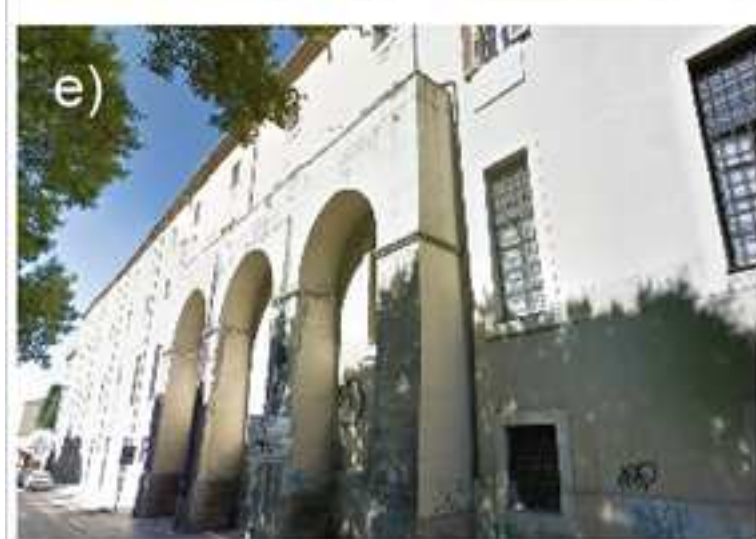
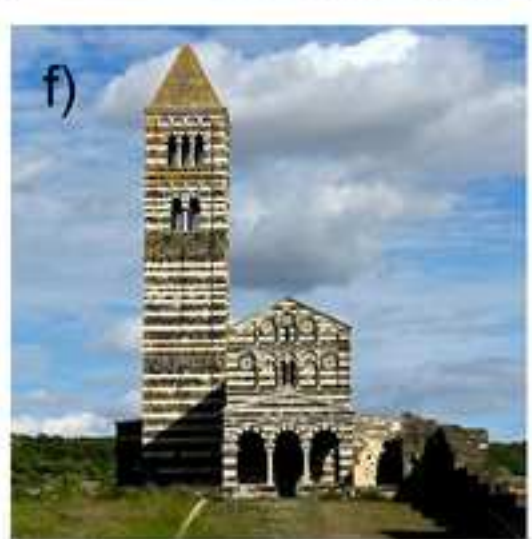
13 The Cathedral of Santa Maria is located in the historic center of Alghero (Fig. 2a). Its building
14 began in the 16th century, but several later additions to the cathedral are known to have taken
15 place, including the final addition of the neoclassical facade. The oldest structures and particularly
16 the bell tower represent Gothic architecture. The building material is sandstone that crops out
17 around Alghero and is locally called “Massacà” (AR). This lithotype crops out near Alghero, along
18 the coast south of the town, and in the suburb of La Pietraia. Surveys identified several coastal
19 quarries, where the eolian sandstone was quarried to be largely used in the town construction since
20 its foundation under the Genoa republic.
21

22 The Basilica of San Gavino (Fig. 2b), located in Porto Torres, is the largest Romanesque church in
23 Sardinia and stands on an ancient paleo-Christian zone of the Turrus Libisonis Roman colony
24 (Mastino et al. 1994). According to some historic documents (Coroneo 1993), the basilica already
25 existed in the 11th century. The church was built by Pisan workers and shares its unusual
26 foundations, characterized by opposing apses, with the coeval church of San Piero a Grado in Pisa.
27 The size of the ashlar of the inner masonry match that of the carving cast found at Ferrinaggiu
28 quarry, which is 2 km south of the basilica. The building stone provenance from this Roman and
29 medieval extraction site was confirmed by petrographic study of micro-cores from the Basilica.
30 The easy workability of the FER favored its indoor use for smooth ashlar, piers, and artifacts.
31 Conversely, the weakness and high porosity of the marly calcarenite (FER) limited its exterior use,

38 The Santa Maria del Regno Church (12th century) is located in Ardara village (Fig 2c). It was built
39 in Pisan–Romanesque style with Lombard influences. Apart from rare pyroclastic rock ashlar in
40 the facade, the church was mainly built with scoriaceous basalt (BAS). Due to the resistance of
41 BAS to degradation, this church is a rare example of a church in the area that has not been heavily
42 restored. This scoriaceous basalt comes from Pliocene–Quaternary lavas flows in this area
43 (Mattioli et al. 2000). This lithotype has been widely used for building in Sardinia, due to its
44 lightness with respect to other building materials.
45

46 The Basilica of Sant’Antioco di Bisarcio (Fig. 2d) was built between the 11th and 13th centuries,
47 and is perhaps the most important basilica in Sardinia built with volcanic material. The church lies
48 on a volcanic hill-top in the countryside near Ozieri. This Romanesque building has Pisan and
49 Lombard stylistic influences. The building is E–W oriented, and has a central nave with an original
50 wooden roof, separated by colonnades supporting arches along two lateral aisles with ribbed
51 vaults. A moderately welded ignimbrite (BIS) was the dominant building material. This ignimbrite
52 crops out widely around the church, and several small extraction sites were recognized. A fine-
53 grained, greenish, epiclastic sandstone (BISG), cropping out north of the basilica, was used for
54 dichromate inserts and decorations in two rows of ashlar on the church walls and more widely in
55 the monastery wall.

58 The Basilica of Santissima Trinità di Saccargia (12th century) is perhaps the most famous and best
59 example of Pisan–Romanesque basilicas in Sardinia (Fig. 2f). The church was entirely built with
60 black basalt (BAS) and white limestone (equivalent to PTW and SS), which provide the
61 contrasting coloration of a Tuscan Romanesque building. The plan of the church is a Latin cross
62
63
64
65
