Contrasting decay of historical building stone: Relationships between petro-physical feature and frontal polymerization treatment suitability on medieval building of north Sardinia (Italy).

Bulletin of Engineering Geology and the Environment

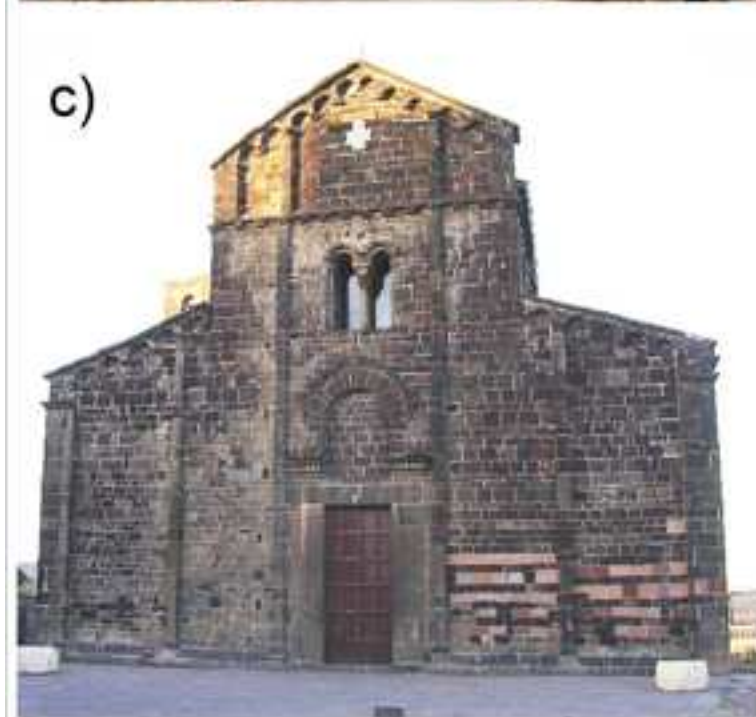
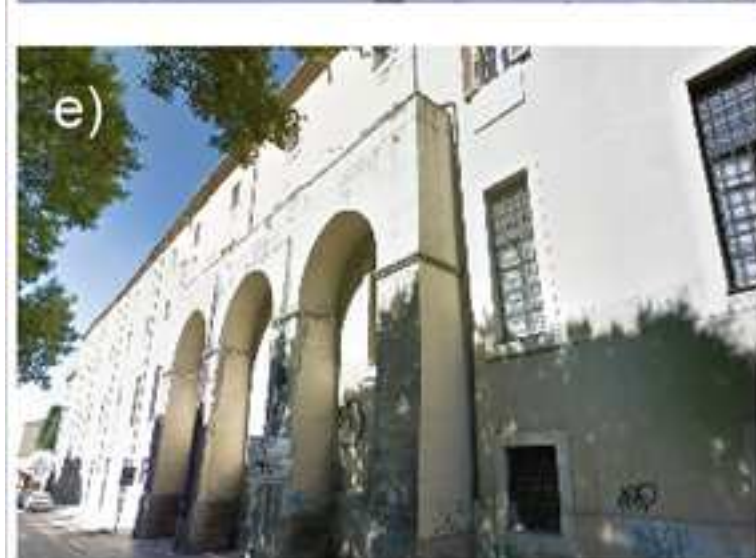
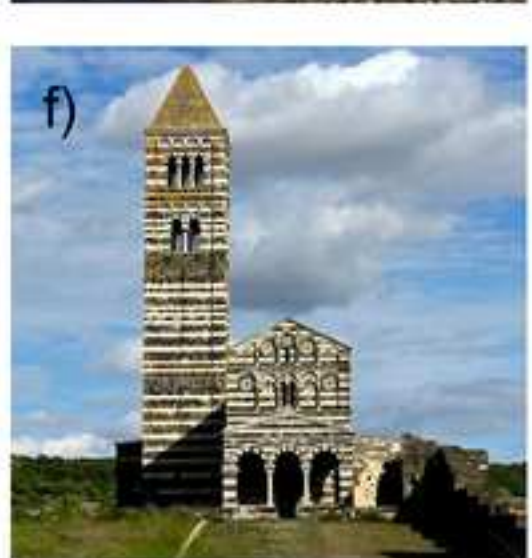
13 The Cathedral of Santa Maria is located in the historic center of Alghero (Fig. 2a). Its building
14 began in the 16th century, but several later additions to the cathedral are known to have taken
15 place, including the final addition of the neoclassical facade. The oldest structures and particularly
16 the bell tower represent Gothic architecture. The building material is sandstone that crops out
17 around Alghero and is locally called “Massacà” (AR). This lithotype crops out near Alghero, along
18 the coast south of the town, and in the suburb of La Pietraia. Surveys identified several coastal
19 quarries, where the eolian sandstone was quarried to be largely used in the town construction since
20 its foundation under the Genoa republic.
21

22 The Basilica of San Gavino (Fig. 2b), located in Porto Torres, is the largest Romanesque church in
23 Sardinia and stands on an ancient paleo-Christian zone of the Turrus Libisonis Roman colony
24 (Mastino et al. 1994). According to some historic documents (Coroneo 1993), the basilica already
25 existed in the 11th century. The church was built by Pisan workers and shares its unusual
26 foundations, characterized by opposing apses, with the coeval church of San Piero a Grado in Pisa.
27 The size of the ashlar of the inner masonry match that of the carving cast found at Ferrinaggiu
28 quarry, which is 2 km south of the basilica. The building stone provenance from this Roman and
29 medieval extraction site was confirmed by petrographic study of micro-cores from the Basilica.
30 The easy workability of the FER favored its indoor use for smooth ashlar, piers, and artifacts.
31 Conversely, the weakness and high porosity of the marly calcarenite (FER) limited its exterior use,

37 The Santa Maria del Regno Church (12th century) is located in Ardara village (Fig 2c). It was built
38 in Pisan–Romanesque style with Lombard influences. Apart from rare pyroclastic rock ashlar in
39 the facade, the church was mainly built with scoriaceous basalt (BAS). Due to the resistance of
40 BAS to degradation, this church is a rare example of a church in the area that has not been heavily
41 restored. This scoriaceous basalt comes from Pliocene–Quaternary lavas flows in this area
42 (Mattioli et al. 2000). This lithotype has been widely used for building in Sardinia, due to its
43 lightness with respect to other building materials.
44

45 The Basilica of Sant’Antioco di Bisarcio (Fig. 2d) was built between the 11th and 13th centuries,
46 and is perhaps the most important basilica in Sardinia built with volcanic material. The church lies
47 on a volcanic hill-top in the countryside near Ozieri. This Romanesque building has Pisan and
48 Lombard stylistic influences. The building is E–W oriented, and has a central nave with an original
49 wooden roof, separated by colonnades supporting arches along two lateral aisles with ribbed
50 vaults. A moderately welded ignimbrite (BIS) was the dominant building material. This ignimbrite
51 crops out widely around the church, and several small extraction sites were recognized. A fine-
52 grained, greenish, epiclastic sandstone (BISG), cropping out north of the basilica, was used for
53 dichromate inserts and decorations in two rows of ashlar on the church walls and more widely in
54 the monastery wall.

56 The Basilica of Santissima Trinità di Saccargia (12th century) is perhaps the most famous and best
57 example of Pisan–Romanesque basilicas in Sardinia (Fig. 2f). The church was entirely built with
58 black basalt (BAS) and white limestone (equivalent to PTW and SS), which provide the
59 contrasting coloration of a Tuscan Romanesque building. The plan of the church is a Latin cross
60
61
62

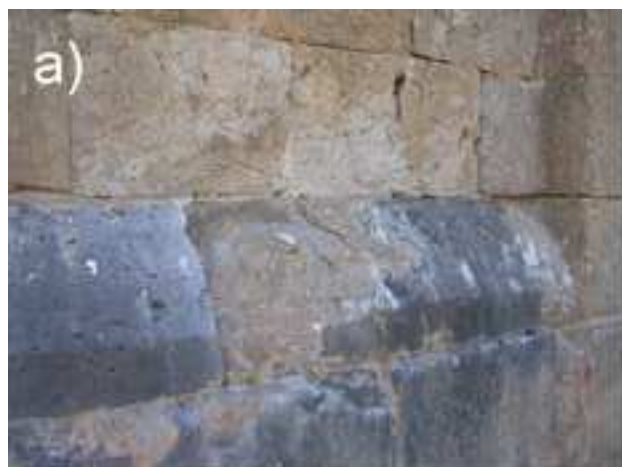
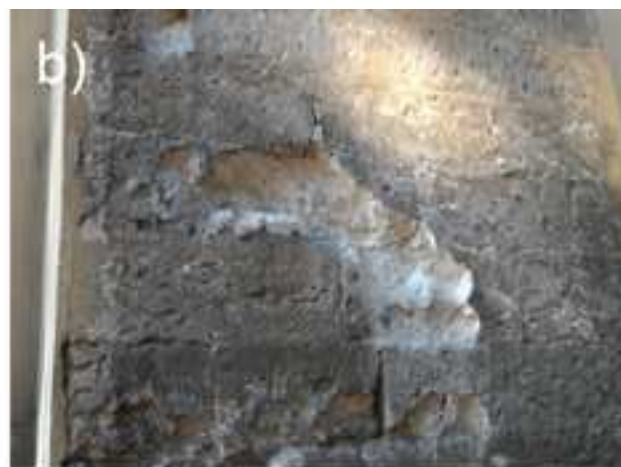
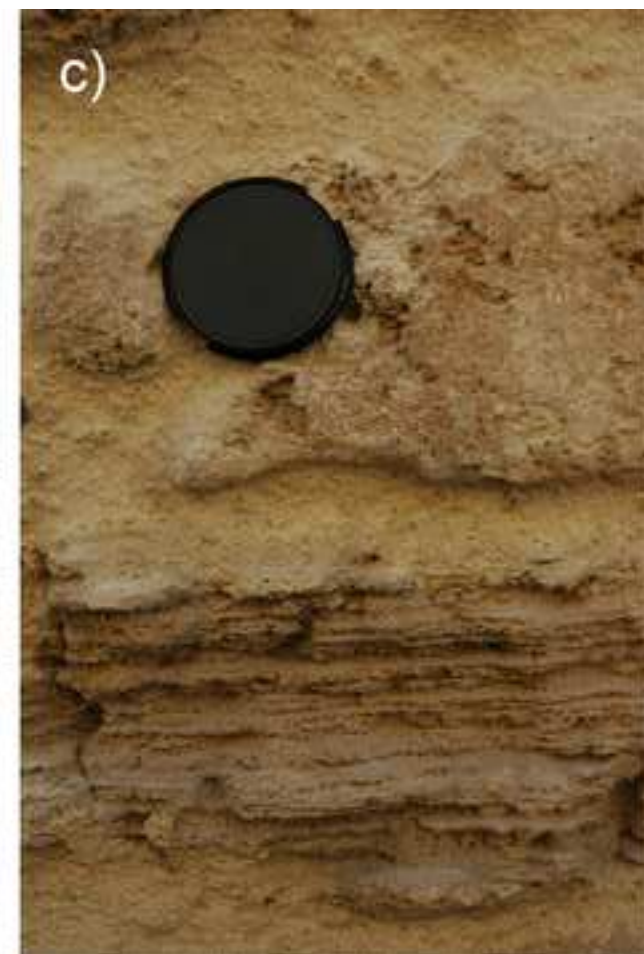
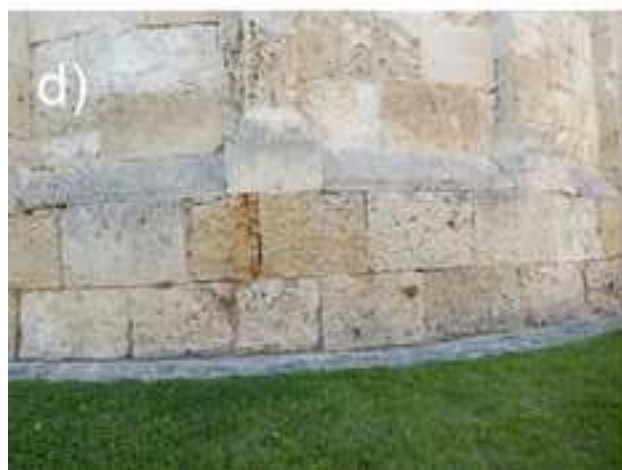
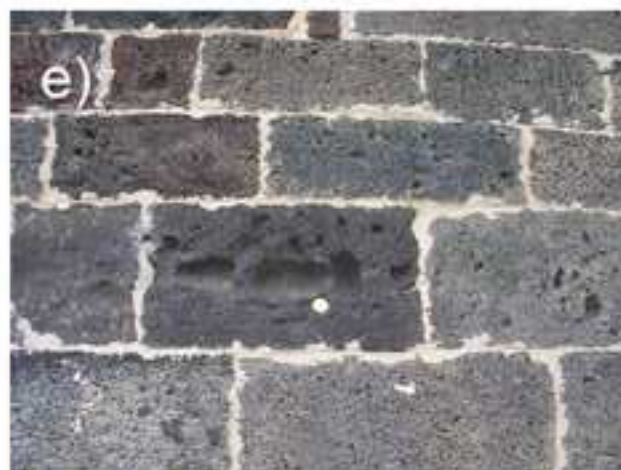
Fig. 8 a) Black patinas in BIS ashlar, b) Pulverization–disaggregation below gypsum-rich black crust in SS ashlar (Sassari), c) Selective degradation in AR sandstone, d) Alveolization in SS and PTW stones (S. Gavino), and e) Alveolization in scoriaceous basalt (Santa Maria del Regno)

Open porosity, water absorption, and capillarity absorption are related to rock texture, and exert a primary control on rock degradation (Pia et al. 2016; Carcangiu et al. 2015). Mineralogical and chemical compositions are also of relevance. For example, the durability of limestones like the SS is easily compromised by urban pollution. The calcareous SS, PTW, and FER building stones in the Basilica of San Gavino, Basilica of Santissima Trinità di Saccargia, and in some other buildings in Sassari share some of the same types of degradation as the volcanic building stones (e.g., alveolization and disaggregation–pulverization). In addition, these rocks are affected by karstic dissolution and experience recrystallization of gypsum in urban and coastal settings. Gypsum recrystallization is common in the SS ashlar buttresses of the old university palace in Sassari (Fig. 2e, Fig. 8b), which underwent treatment with an organic protective film. The desired

1 effect of these films is to improve the durability of the stone, but has caused abundant
2 recrystallization of gypsum at the contact between the film and ashlar surface that underwent
3 disintegration followed by detachment of the film (Fig. 8b). The degradation types observed in the
4 SS samples are comparable with those identified in the PTW and FER samples. However, PTW
5 shows a better resistance to decay due to its relatively low capillarity absorption with respect to SS
6 and FER. Moreover, the inhomogeneous texture of PTW, characterized by large voids (up to 1
7 cm), hinders capillary rise of water. For this reason, the PTW building stone was extensively used
8 in the basal ashlar of buildings, such as the Basilica of San Gavino, and where SS and FER are
9 predominant in the internal walls. Some FER ashlar used for external masonry show deep
10 alveolization or disintegration due to the dissolution of micritic matrix. Biological patinas mainly

24 The degradation of basalt building stone observed at Santa Maria del Regno and Saccargia is
25 restricted to minor and diffuse alveolization in the scoriaceous facies. In contrast, the rare
26 ignimbrite ashlar show exfoliation and alveolization.

27 Finally, only alveolization and disintegration affect the AR sandstone, which is principally due to
28 the dissolution of the carbonate cement. In some ashlar with thin, cross-bedded stratification,
29 selective decay has occurred, reflecting the differential diagenesis of each layer.
