Contrasting decay of historical building stone: Relationships between petro-physical feature and frontal polymerization treatment suitability on medieval building of north Sardinia (Italy).

Contrasting decay of historical building stone: Relationships between petro-physical feature and frontal polymerization treatment suitability on medieval building of north Sardinia (Italy) / Cuccuru, Stefano; Oggiano, Giacomo; Meloni, Paola; Mariani, Alberto; Mameli, Paola. - In: BULLETIN OF ENGINEERING GEOLOGY AND THE ENVIRONMENT. - ISSN 1435-9529. - 78:3(2019), pp. 1669-1682. [10.1007/s10064-018-1242-5]

Bulletin of Engineering Geology and the Environment

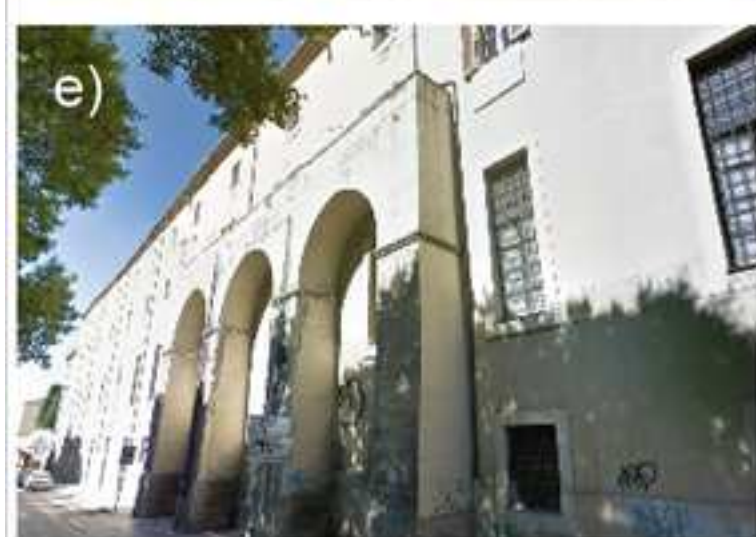
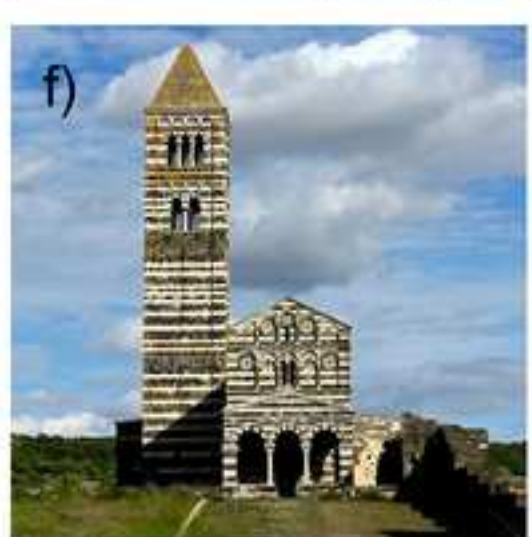
13 The Cathedral of Santa Maria is located in the historic center of Alghero (Fig. 2a). Its building
14 began in the 16th century, but several later additions to the cathedral are known to have taken
15 place, including the final addition of the neoclassical facade. The oldest structures and particularly
16 the bell tower represent Gothic architecture. The building material is sandstone that crops out
17 around Alghero and is locally called “Massacà” (AR). This lithotype crops out near Alghero, along
18 the coast south of the town, and in the suburb of La Pietraia. Surveys identified several coastal
19 quarries, where the eolian sandstone was quarried to be largely used in the town construction since
20 its foundation under the Genoa republic.
21

22 The Basilica of San Gavino (Fig. 2b), located in Porto Torres, is the largest Romanesque church in
23 Sardinia and stands on an ancient paleo-Christian zone of the Turrus Libisonis Roman colony
24 (Mastino et al. 1994). According to some historic documents (Coroneo 1993), the basilica already
25 existed in the 11th century. The church was built by Pisan workers and shares its unusual
26 foundations, characterized by opposing apses, with the coeval church of San Piero a Grado in Pisa.
27 The size of the ashlar of the inner masonry match that of the carving cast found at Ferrinaggiu
28 quarry, which is 2 km south of the basilica. The building stone provenance from this Roman and
29 medieval extraction site was confirmed by petrographic study of micro-cores from the Basilica.
30 The easy workability of the FER favored its indoor use for smooth ashlar, piers, and artifacts.
31 Conversely, the weakness and high porosity of the marly calcarenite (FER) limited its exterior use,

37 The Santa Maria del Regno Church (12th century) is located in Ardara village (Fig 2c). It was built
38 in Pisan–Romanesque style with Lombard influences. Apart from rare pyroclastic rock ashlar in
39 the facade, the church was mainly built with scoriaceous basalt (BAS). Due to the resistance of
40 BAS to degradation, this church is a rare example of a church in the area that has not been heavily
41 restored. This scoriaceous basalt comes from Pliocene–Quaternary lavas flows in this area
42 (Mattioli et al. 2000). This lithotype has been widely used for building in Sardinia, due to its
43 lightness with respect to other building materials.
44

45 The Basilica of Sant’Antioco di Bisarcio (Fig. 2d) was built between the 11th and 13th centuries,
46 and is perhaps the most important basilica in Sardinia built with volcanic material. The church lies
47 on a volcanic hill-top in the countryside near Ozieri. This Romanesque building has Pisan and
48 Lombard stylistic influences. The building is E–W oriented, and has a central nave with an original
49 wooden roof, separated by colonnades supporting arches along two lateral aisles with ribbed
50 vaults. A moderately welded ignimbrite (BIS) was the dominant building material. This ignimbrite
51 crops out widely around the church, and several small extraction sites were recognized. A fine-
52 grained, greenish, epiclastic sandstone (BISG), cropping out north of the basilica, was used for
53 dichromate inserts and decorations in two rows of ashlar on the church walls and more widely in
54 the monastery wall.

56 The Basilica of Santissima Trinità di Saccargia (12th century) is perhaps the most famous and best
57 example of Pisan–Romanesque basilicas in Sardinia (Fig. 2f). The church was entirely built with
58 black basalt (BAS) and white limestone (equivalent to PTW and SS), which provide the
59 contrasting coloration of a Tuscan Romanesque building. The plan of the church is a Latin cross
60
61
62

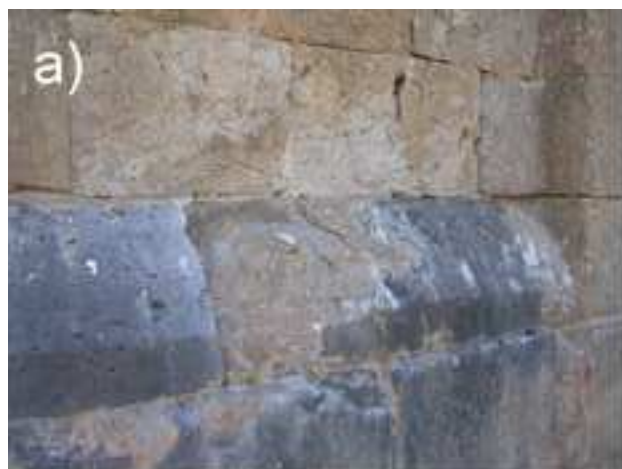
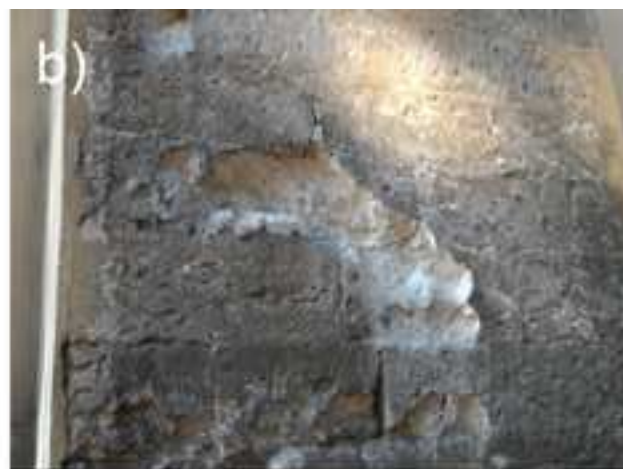
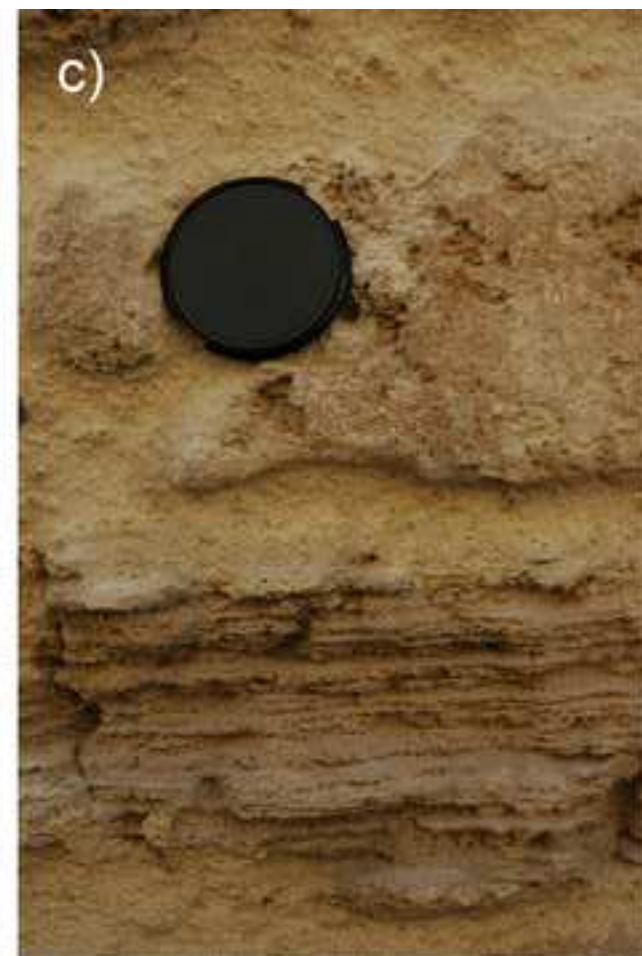
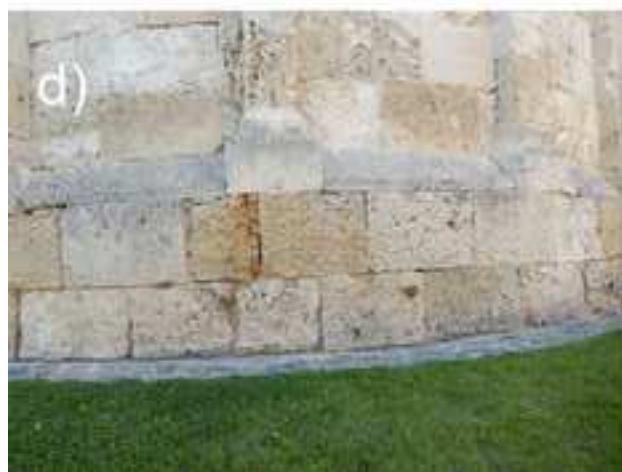
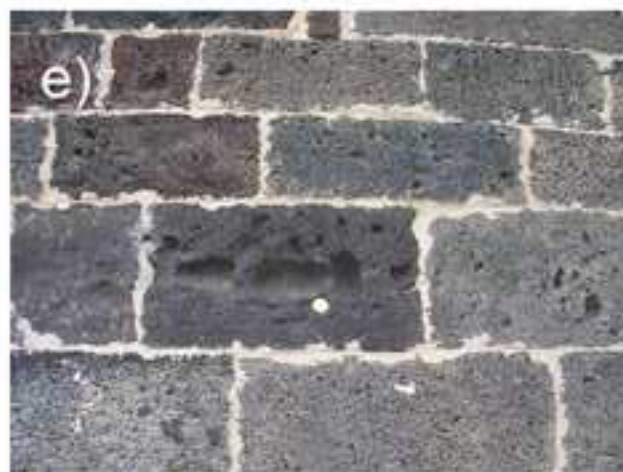
Fig. 8 a) Black patinas in BIS ashlar, b) Pulverization–disaggregation below gypsum-rich black crust in SS ashlar (Sassari), c) Selective degradation in AR sandstone, d) Alveolization in SS and PTW stones (S. Gavino), and e) Alveolization in scoriaceous basalt (Santa Maria del Regno)

Open porosity, water absorption, and capillarity absorption are related to rock texture, and exert a primary control on rock degradation (Pia et al. 2016; Carcangiu et al. 2015). Mineralogical and chemical compositions are also of relevance. For example, the durability of limestones like the SS is easily compromised by urban pollution. The calcareous SS, PTW, and FER building stones in the Basilica of San Gavino, Basilica of Santissima Trinità di Saccargia, and in some other buildings in Sassari share some of the same types of degradation as the volcanic building stones (e.g., alveolization and disaggregation–pulverization). In addition, these rocks are affected by karstic dissolution and experience recrystallization of gypsum in urban and coastal settings. Gypsum recrystallization is common in the SS ashlar buttresses of the old university palace in Sassari (Fig. 2e, Fig. 8b), which underwent treatment with an organic protective film. The desired

1 effect of these films is to improve the durability of the stone, but has caused abundant
2 recrystallization of gypsum at the contact between the film and ashlar surface that underwent
3 disintegration followed by detachment of the film (Fig. 8b). The degradation types observed in the
4 SS samples are comparable with those identified in the PTW and FER samples. However, PTW
5 shows a better resistance to decay due to its relatively low capillarity absorption with respect to SS
6 and FER. Moreover, the inhomogeneous texture of PTW, characterized by large voids (up to 1
7 cm), hinders capillary rise of water. For this reason, the PTW building stone was extensively used
8 in the basal ashlar of buildings, such as the Basilica of San Gavino, and where SS and FER are
9 predominant in the internal walls. Some FER ashlar used for external masonry show deep
10 alveolization or disintegration due to the dissolution of micritic matrix. Biological patinas mainly

24 The degradation of basalt building stone observed at Santa Maria del Regno and Saccargia is
25 restricted to minor and diffuse alveolization in the scoriaceous facies. In contrast, the rare
26 ignimbrite ashlar show exfoliation and alveolization.

27 Finally, only alveolization and disintegration affect the AR sandstone, which is principally due to
28 the dissolution of the carbonate cement. In some ashlar with thin, cross-bedded stratification,
29 selective decay has occurred, reflecting the differential diagenesis of each layer.
